# Northumberland County Council

## Route Road Safety Study

### B6318 Heddon-on-the-Wall to A68 Errington Arms Roundabout

DATE: February 2023

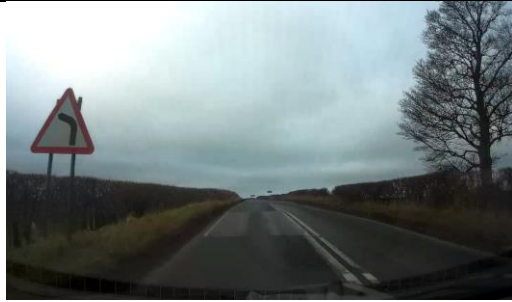
**Photo 5 - Example of bend warning sign which may benefit from being located on yellow backing board with a speed reminder.**

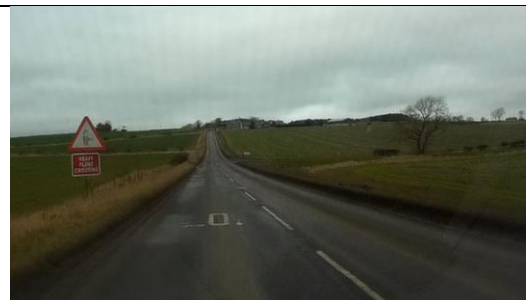
**Photo 12 - Example of worn sign and SLOW road markings which can be improved.**

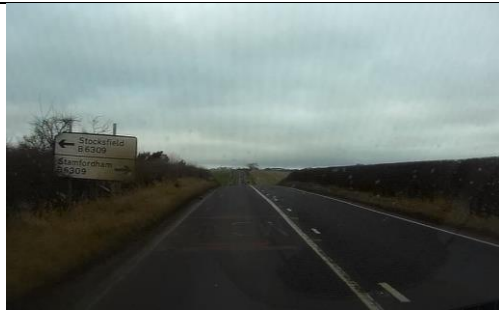
**Photo 13 – Worn stack type advanced direction sign which has slipped on posts. Opportunity to improve advanced signage and provide SLOW road markings and red strips.**

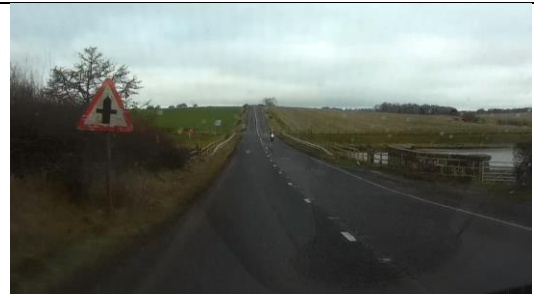
**Photo 14 - Worn junction warning sign which can be improved and opportunity to provide SLOW road markings and red strips.**

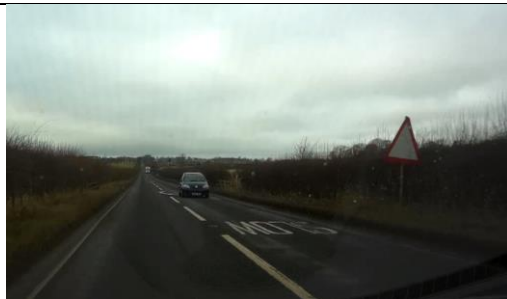
**Photo 15 – Warning sign face is badly worn and requires replacement and sign is twisted to face in the wrong direction.**

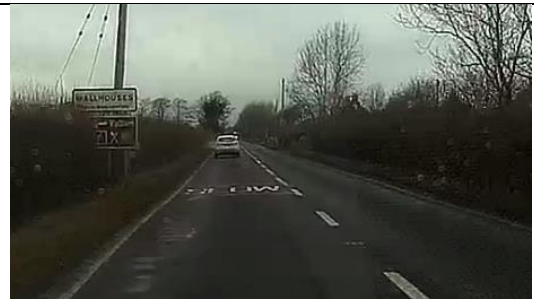
**Photo 16 - Example of advanced direction obscured by vegetation.**

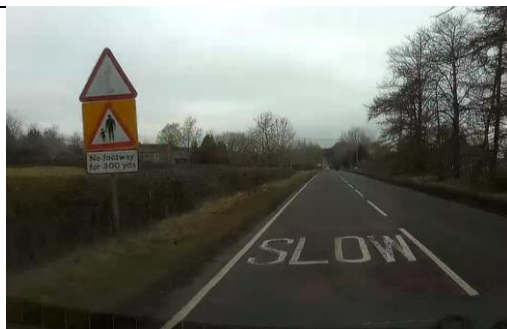
**Photo 17 - Warning sign face is badly worn and requires replacement**

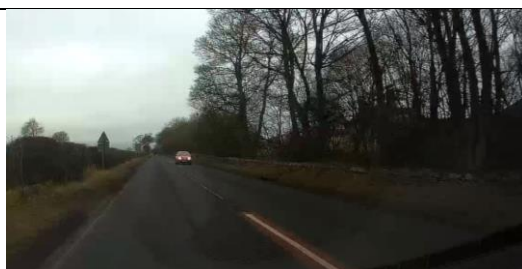
**Photo 19 – Example worn set of road markings/studs alongside other markings which have been refreshed more recently.**

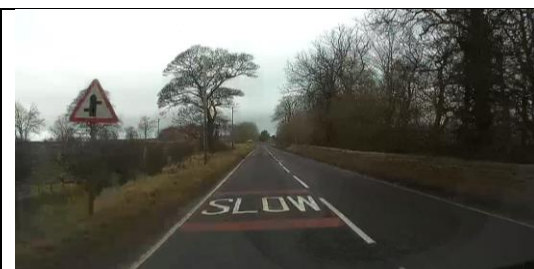
**Photo 20 – Example of staggered junction warning sign which could have improved conspicuity and a supplementary distance plate.**

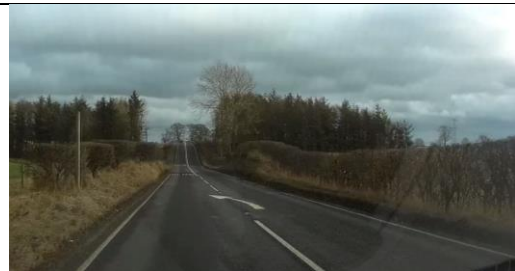
**Photo 24 – Missing warning sign (vacant post) in advance of a section of road with non standard vertical and horizontal alignment.**

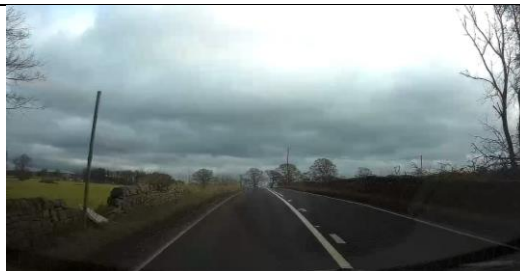
**Photo 25 - Missing warning sign (vacant post).**

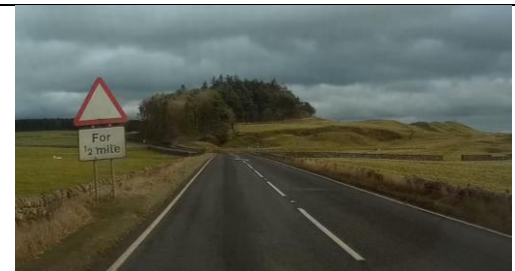
**Photo 26 – Badly worn double bend warning sign. Sign and supplementary plate could be enhanced on yellow backing board**

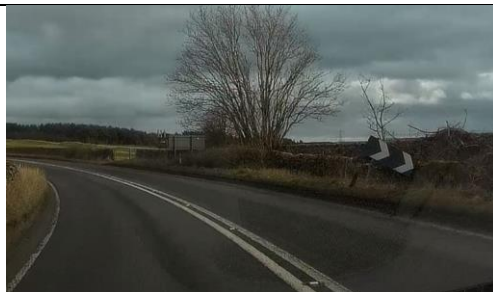
**Photo 27 – Chevron sign has been dislodged and is facing the wrong way – should be directing traffic left around the bend.**

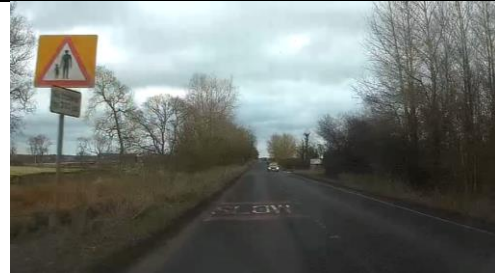
**Photo 30 – Twisted supplementary plate and worn SLOW road markings and centre line road markings.**

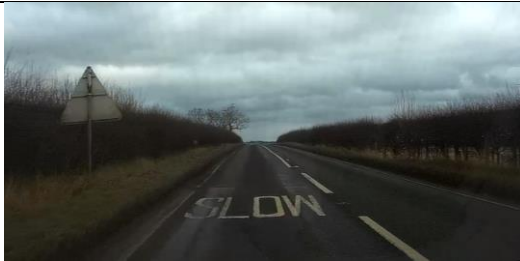
**Photo 31 – Warning sign has been twisted to face wrong direction and sign appears worn**

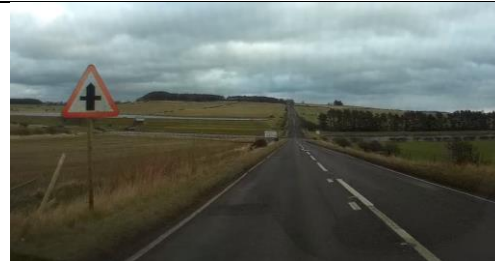
**Photo 32 - Example of crossroads warning sign which could be enhanced on yellow backing board with a supplementary distance plate**

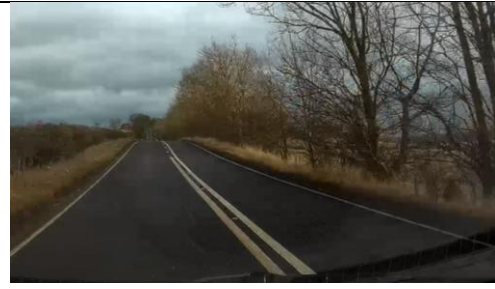
**Photo 34 – Check that termination of double white lines and start of broken line is located correctly on an undulating section of road.**

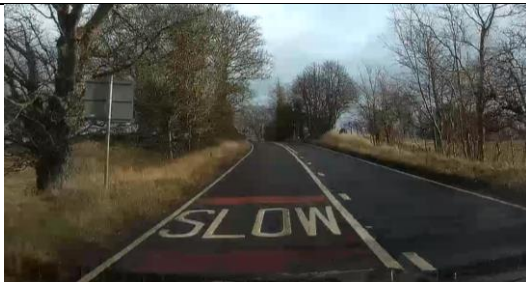
**Photo 35 - Warning sign has been twisted to face wrong direction**

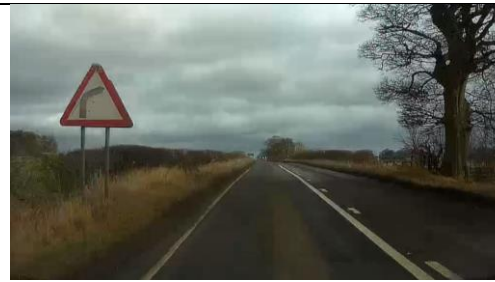
**Photo 36 - Example of worn warning sign which could be replaced and enhanced.**

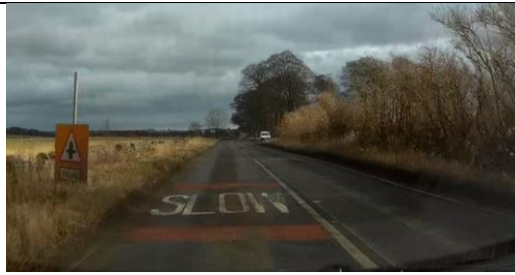
**Photo 37 – Yellow back crossroads warning sign has slipped on existing post.**

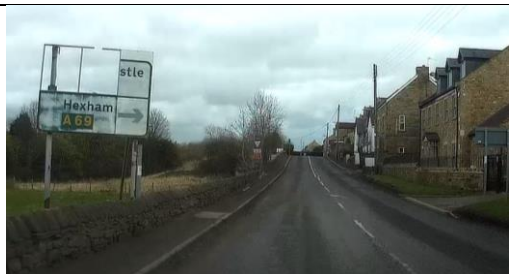
**Photo 41 – Advanced stack type advanced direction sign which requires replacement and which could be re-designed to be map type showing the junction layout ahead and provided with SLOW markings and red strips.**

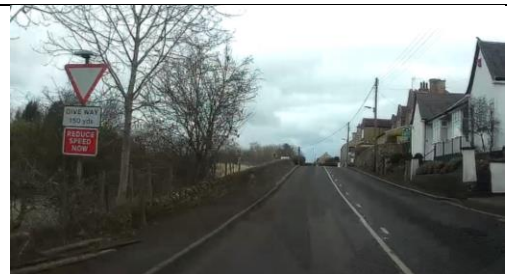
**Photo 42 – Advance junction warning sign could be enhanced and provided with SLOW markings and red strips.**
