Appendix 1B

Survey of Reinforced Concrete Details and Lintels at the
Maisonette Blocks in Blyth

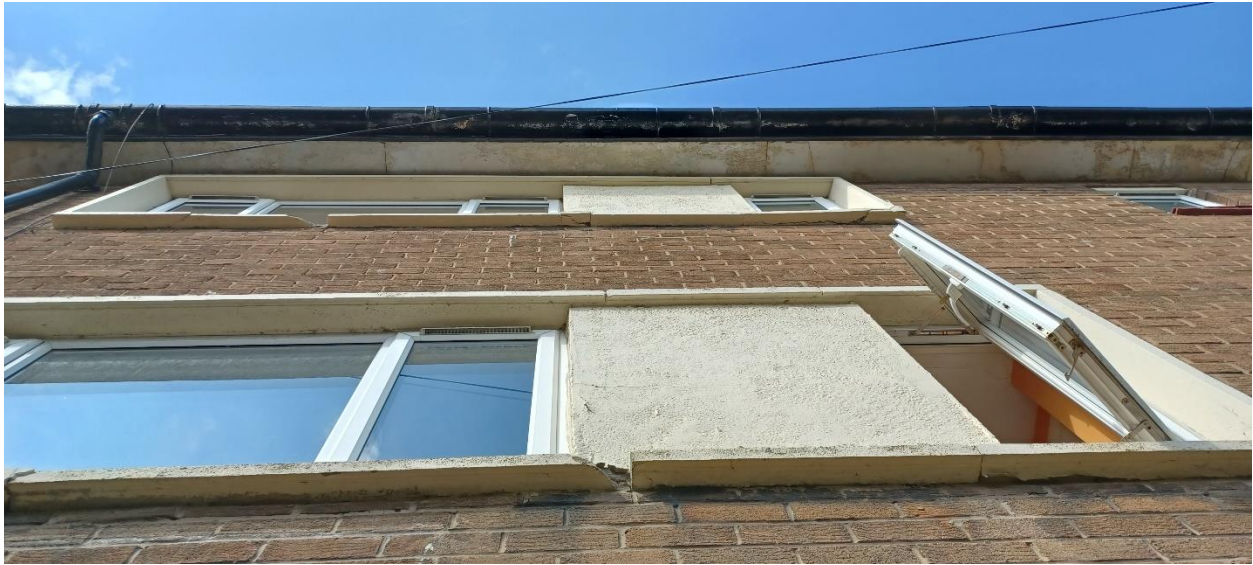
Projecting boot lintels and projecting concrete surround detailing - The condition of the exposed reinforced edges of all projecting boot lintels and concrete surround details vary in severity but they generally show signs of the same defects. The steel reinforcement in the concrete has corroded causing the steel to expand which has cracked the concrete. *The cause of the defect is due to carbonation* and the projection on the concrete detail has allowed the concrete to become saturated and retain moisture longer than if it was flush with the brickwork.

The photo below taken on the front elevation shows missing concrete on the projecting concrete cills and cracks on the boot lintels and side details.

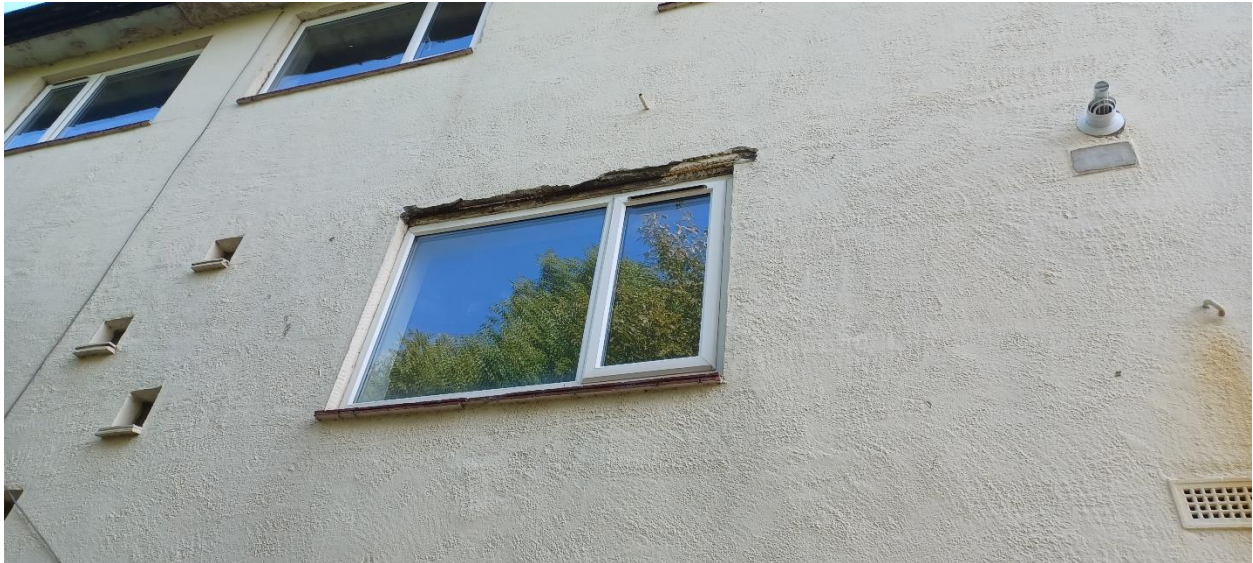
Flush boot lintels - The condition of the flush boot lintels are generally better due to being protected more from the rain. However, as can be seen from the photo below taken on the rear elevation some of the flush lintels also share the same defect as the projecting details.
