Project Title: Astley High School					
Project No.: 573					
Document Title: Pool Water Treatment and Tank Audit Report					
Document Status: Initial Issue					
Document Reference: 573-M8.05-1					
Revision	Prepared		Checked		Item/change description
	Initial	Date	Initial	Date	
1	JC	01.10.19	TD	02.10.19	Initial version of document.

- 1.1 Devin Consulting Limited was requested by Faithful & Gould to carry out a condition assessment of the swimming pool water treatment and pool tank.

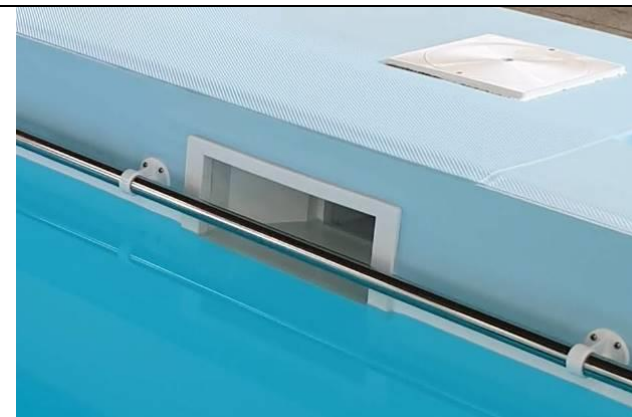
Pool base outlet fittings	A	<p>Description: 2 No. outlets located on the base of the pool in the deep end, of approximately 400mm x 400mm, appeared to be stainless steel finish.</p> <p>Comment:</p> <ul style="list-style-type: none"> • Water velocity through the apertures based on the measured flow rate is 0.06m/s (assumes a free area of 30%). This is within the allowable maximum of 0.25m/s (BS EN 13451-3). • The velocity through the outlets based on the PWTAG minimum flow rate would be 0.22m/s, which is compliant with BS EN 13451-3. • Condition of the grilles appears good. <p>Recommendation:</p> <ul style="list-style-type: none"> • <i>Retain existing outlet grilles.</i> • <i>The grilles could accommodate the PWTAG minimum flow rate, although the size of the outlet sumps would need to be checked.</i>
Surface water removal	C	<p>Description: 3 No. skimmer boxes located on the short wall at the deep end of the pool. Skimmers complete with strainer basket accessed from the pool surround; all finishes in white plastic.</p> <p>Comment:</p> <ul style="list-style-type: none"> • Condition of the skimmers was good. • The pool hand rail is installed across the front of the skimmers. Whilst the clearances are acceptable under BS EN 13451 the arrangement is awkward and could cause an entrapment issue. • The pool water level was low by approximately 100mm meaning that the amount of water removed by the skimmers will be limited. • The overall pool circulation, including the number and position of skimmers and inlets is questionable. • The use of skimmers in public pools is not recommended by PWTAG as the surface water removal and hence water quality will be limited. PWTAG recommends a pool with as much surface water removal as possible, such as a deck level pool. <p>Recommendation:</p> <ul style="list-style-type: none"> • <i>Pool water level to be maintained at the correct level.</i> • <i>Skimmer hand rail area should be risks assessed and managed.</i>

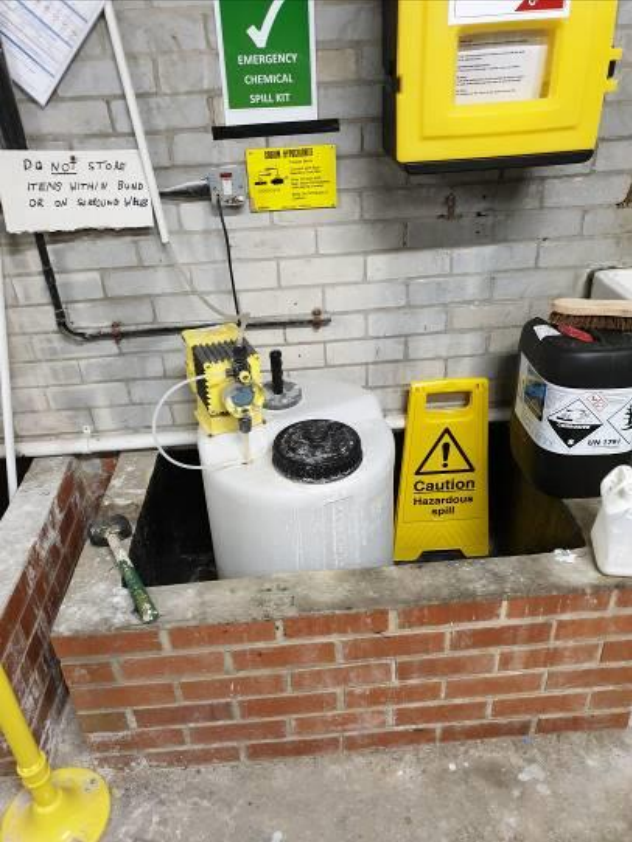
Sodium hypochlorite dosing system	C	<p>Description: 100L capacity day tank with LMI pump and manual stir. Sodium hypochlorite transferred to day tank from carboys by hand tank. Day tank in lined bund of brick construction. Age of all unknown.</p> <p>Comment:</p> <ul style="list-style-type: none"> • Condition of day tank and pump is fair with some external staining but generally functional. • Day tank and bund are located in the plant room adjacent to the acid dosing area. • Condition of pump isolator is poor with external marking/discolouration. • Location of the chlorine dosing system in the plant room, in particular adjacent to the acid dosing system significantly increases the risk of an incident such as chlorine gas release. • A carboy was balanced on the bund wall. <p>Recommendation:</p> <ul style="list-style-type: none"> • <i>In the short-term, measures should be investigated to improve segregation between the chlorine donor and acid dosing areas such as a dividing wall or barrier. PWTAG states that acid and alkalis should not be in adjacent bunds.</i> • <i>It is imperative that the management and storage of chemicals is maintained to a high standard, suitably risk assessed and regularly reviewed. Chemicals should only be stored within the correct bunds provided.</i> • <i>As part of wider upgrade works dedicated chemical storage and dosing areas should be provided.</i> • <i>It should be ensured all chemical dosing lines are suitably supported and renewed as required.</i> • <i>Electrical items should be reviewed and replaced as required.</i>

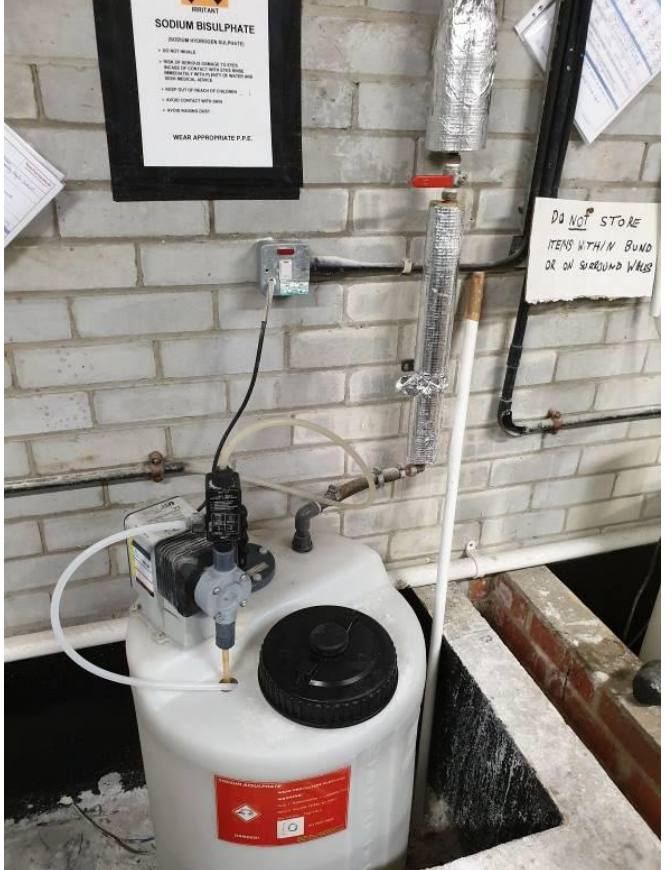
Sodium bisulphate dosing system	B	<p>Description: 100L capacity day tank with USF pump and manual stir. Sodium bisulphate dosed by hand with manual fill connection for water. Day tank in lined bund of brick construction. Age of all unknown.</p> <p>Comment:</p> <ul style="list-style-type: none"> • Condition of day tank and pump is good and appears newer than the chlorine system. • Day tank and bund are located in the plant room adjacent to the chlorine dosing area. • Condition of pump isolator is fair with some external marking/ discolouration. • Location of the acid dosing system in the plant room, in particular adjacent to the chlorine dosing system significantly increases the risk of an incident such as chlorine gas release. • PWTAG states that the segregation and storage rules should be strictly applied so that the risk of mixing the sodium bisulphate with a chlorine source is removed. The current installation falls significantly short of this. <p>Recommendation:</p> <ul style="list-style-type: none"> • <i>A motorised stirring system would improve mixing.</i> • <i>It should be ensured all chemical dosing lines are suitably supported and renewed as required.</i> • <i>Refer to other recommendations of chemical storage inadequacy.</i>

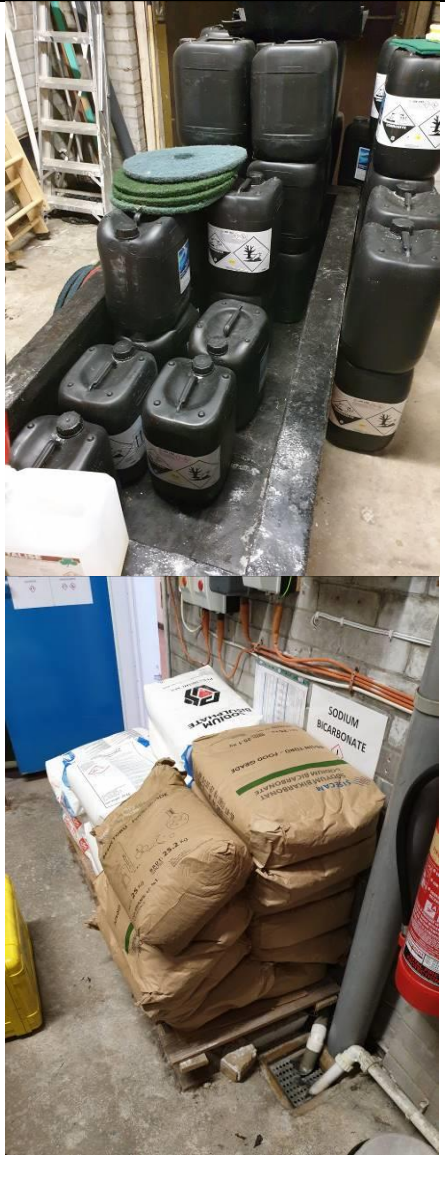
Chemical Storage	D	<p>Description:</p> <ul style="list-style-type: none"> All chemical dosing and storage is within the plant room. <ul style="list-style-type: none"> Sodium hypochlorite is stored in a central bunded area. Sodium bisulphate, calcium chloride and sodium bicarbonate bags are stored on wooden pallets adjacent to the internal access door. <p>Comment:</p> <ul style="list-style-type: none"> Chemical storage provision should be such as to enable safe storage of chemicals, different chemicals should be stored separately and separated from the rest of the building. There are a large number of empty chemical carboys (24 in total) within the plant room which is further impacting the safe storage of chemicals. For sodium hypochlorite, a maximum of 2 months' supply of chemical's should be on site, ideally less. Chemical management is generally poor with items balanced on bunds and dissimilar chemicals stored on the same pallets. Dedicated, segregated storage areas should be provided. Although there is external access to the plant room via double doors there is a step up from the outside. Operator advised that chemical deliveries are unloaded in car park and delivered through the school corridor and into the plant room. Chemical deliveries require that the chemical delivery route be controlled and the chemicals securely transported in a bunded trolley or similar. Access to the chemical delivery route should be prevented during deliveries. <p>Recommendation:</p> <ul style="list-style-type: none"> <i>Safe chemical storage facilities should be provided, with adequate chemical separation and safety provisions adjacent to chemical storage areas.</i> <i>The minimum amount of chemicals required should be stored on site with empty carboys regularly removed.</i> <i>As part of wider upgrade works dedicated chemical stores should be provided.</i> <i>It is recommended that the chemical delivery route be reassessed with the objective to minimise the transfer distance from delivery vehicle to store and minimise the route through public areas/student areas. Consideration should be given to delivering chemicals direct from the external area to the plant room, with modifications to the access as required to achieve this.</i> <i>All chemicals not related to water treatment should be removed and chemicals should not be stored on bund walls.</i>

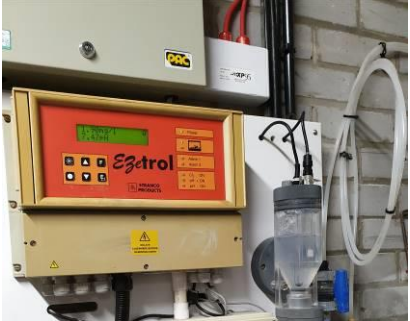
Chemical controller	D	<p>Description: Ezetrol chemical controller age unknown.</p> <p>Comment:</p> <ul style="list-style-type: none"> • External condition is poor, age unknown but functioning satisfactorily. • Operator was unable to identify chlorine or pH set points. • Controller safety functions unknown. <p>Recommendation: The unit is likely approaching the end of its service life and should be replaced.</p>

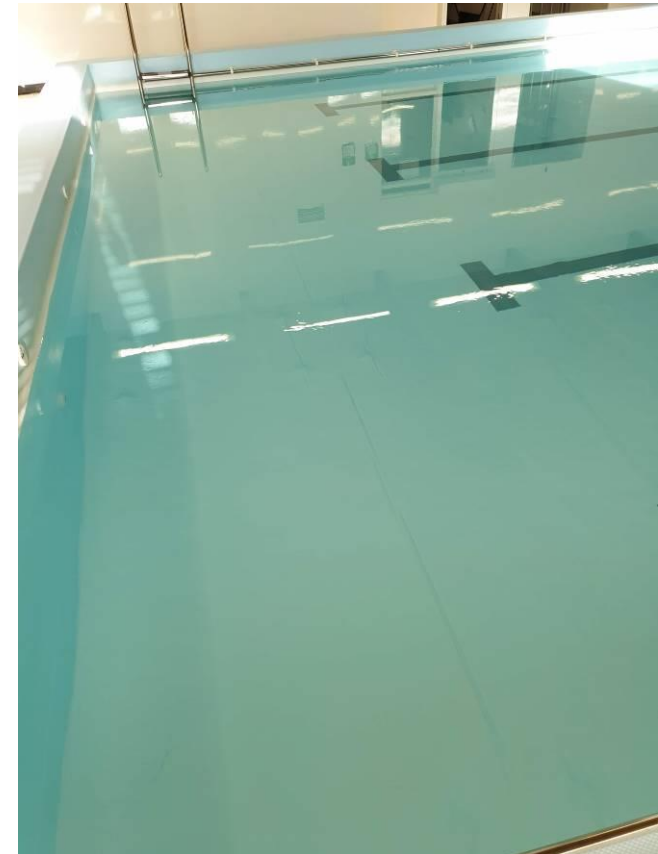
- Operator advised that Kingspan insulation is installed under the liner.
- Signs of fixing bolts/caps for the insulation can be seen under the liner, this is may damage the liner over time.
- The liner is showing signs of creases.
- Liner was installed as part of the refurbishment works in 2013.
- Textured lane lines are provided on the pool base.
- Pool construction underneath is unknown.

2 No. stainless steel access steps are positioned in diagonally opposite corners. Access steps rest on the top of the pool unsecured. The bracket on the access steps into the deep end has sheared meaning the ladder is not secure and moves when used. This should not be used until it is replaced.

The junction between the pool surround and walls is in a poor condition, the pool surround in general is not in a good condition.

- The pool liner is showing creases and the securing bolts for the insulation underneath, this may cause the liner to fail.
