Kirknewton Conservation Area Character Appraisal

2. Summary of Special Interest

3. Background to Kirknewton Conservation Area

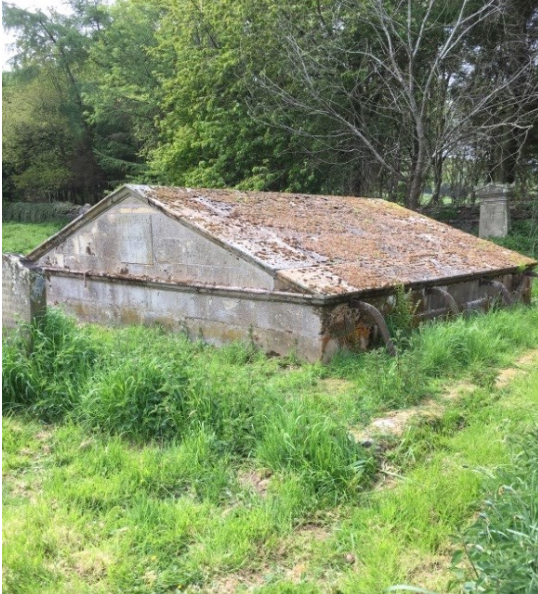
Figure 3: Davison mausoleum

II listed Davison Mausoleum is considered to be at risk and the grade II listed Davison grave is considered to be vulnerable. Some of the older listed gravestones are severely weathered and the engraving indecipherable and hence could also be considered to be at risk. The remainder of the listed buildings are in generally good condition and not considered to be at risk.

The Davison Mausoleum is a low oblong structure with moulded cornice pediment gables on a stone roof constructed to intern the Davison family. Made from ashlar stone and dated to the late 18th century, its side walls are supported by S-shaped iron stanchions and have a three- stepped decent to the doorway on the west end of the mausoleum. Alexander Davison was the son of a prominent local landowner who born in Lanton. In later life he became a friend and confident of Admiral Nelson. The Lanton Memorial, an obelisk erected in the memory of a member of the Davison family,

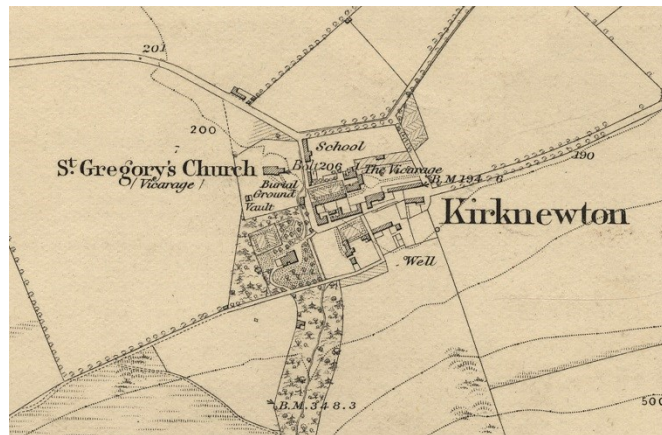
Figure 7: First edition Ordnance Survey 25-inch c.1860

In 1828 the form of the village had a clear resemblance to the village of today, with the church, vicarage and East and West Kirknewton Farms established. By 1860 the village school and Kirknewton House had been constructed and the church substantially rebuilt by the well-known local architect John Dobson who redesigned much of Newcastle upon Tyne. The following decades saw the building of agricultural workers cottages, a school teacher's house and the enlargement of the school. The church tower was added around 1880.

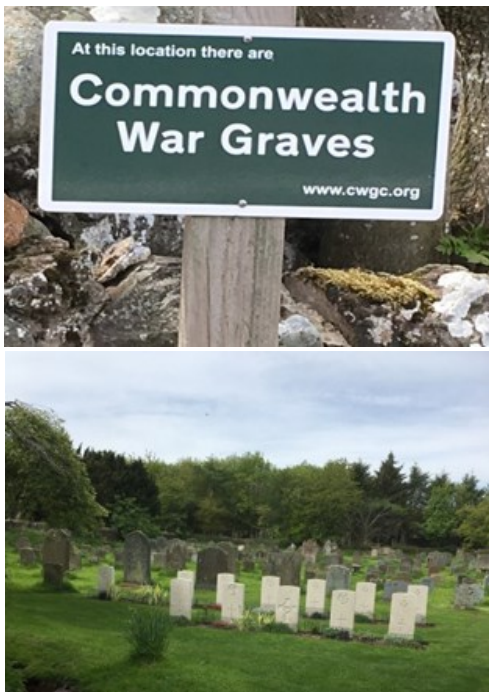
Figure 11a: Commonwealth war graves

The outward form of Kirknewton has altered relatively little in the 20th century, but this masks profound changes in the local economy and population. The First and Second World Wars drew men away from the Glendale estates to fight. The many who never returned are commemorated on the war memorial at Kirknewton. Nearby Milfield Airfield was established as an RAF base to intercept Luftwaffe bombers attacking from Norway and later became one of the main centres for training aircrew in the 'air to ground' attack methods vital for the control of the Normandy beach-heads and the following 'push' through Europe. The airfield was manned by pilots of many nationalities and the tombstones of airmen killed in action (and during training) can still be seen in Kirknewton churchyard; all of the tombstones are distinctive and decorated with the crest of the particular squadron or wing to which the deceased belonged.

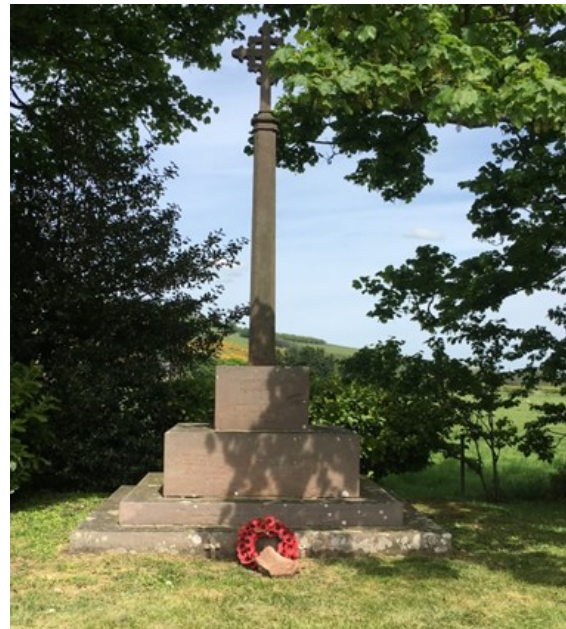
Figure 11b: War memorial

Other important focal points include the War Memorial, located to the east of the village and separated from its core by the busy B6351. It serves as a focal point and can clearly be seen from within the village. There is also an intrinsic and important link with the village and the wider valley to the service men and women who came from the area and gave their lives for their country in two World Wars.

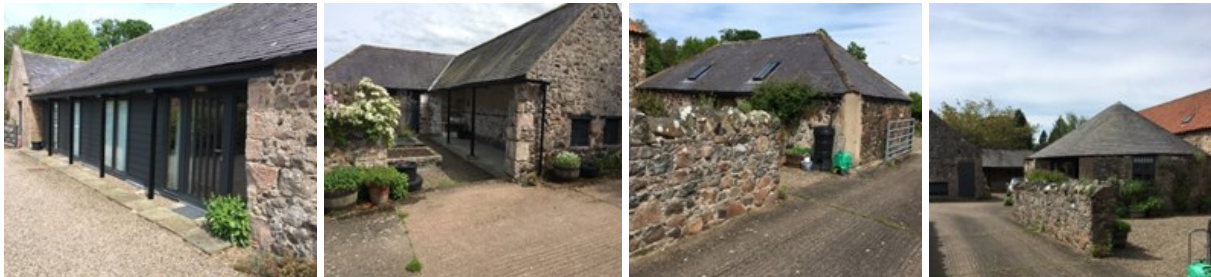
Figure 12: East Kirknewton Farm

Since its inception Kirknewton has been an agricultural settlement, the development of which can be traced through its medieval origins to the present East and West Kirknewton Farms. The compact and organic street pattern is typical in the core of the Village. The farms appear to have developed along traditional farming lines which have led to a compact form consisting of byres, granaries, cart shed, barns, gin gangs, stockyards and farmworkers' cottages as an integral part of each farmstead. The farmsteads are broadly of a loose courtyard type, developed in the late 18th and early 19th centuries, with shelter sheds with granaries above on the north side and an engine house or "gin gang" which has survived, although recently

converted, at East Kirknewton Farm. Rows of small cottages for farmworkers are also evident, which is a characteristic feature of regional farmsteads, comprising a terrace set apart from the farmstead.

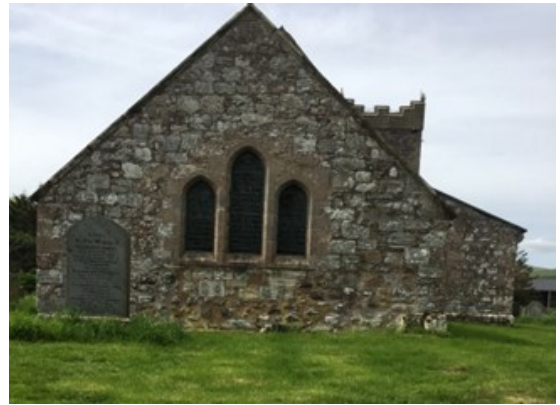
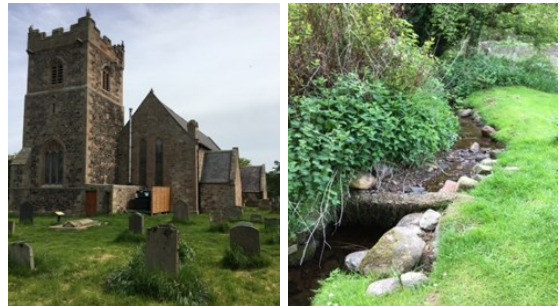
Figure 14: Church, churchyard and stream in the churchyard

The church (dedicated to St Gregory the Great) and churchyard form another dominating element contributing to the character of Kirknewton. The church is the tallest structure within Kirknewton and as such is testament to its status within the village and valley of Glendale. The churchyard surrounding the church is well maintained and as such it makes a positive contribution to the character of the Conservation Area. Many of the headstones within the churchyard are very old and have weathered. A small stream runs through the Graveyard close to the south-eastern entrance is an attractive element adding

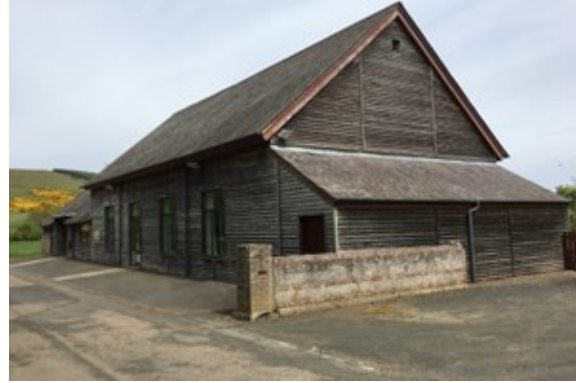
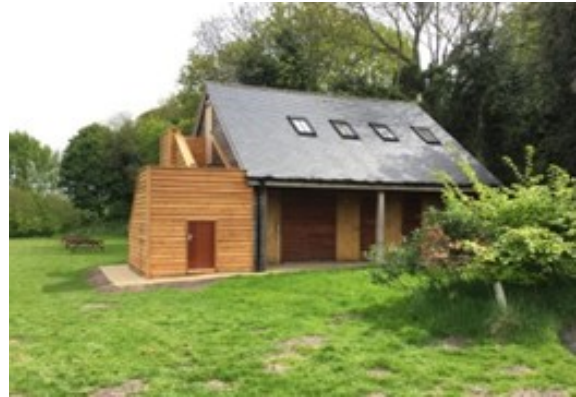
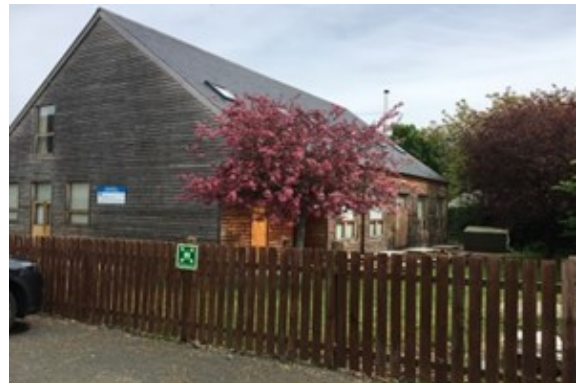
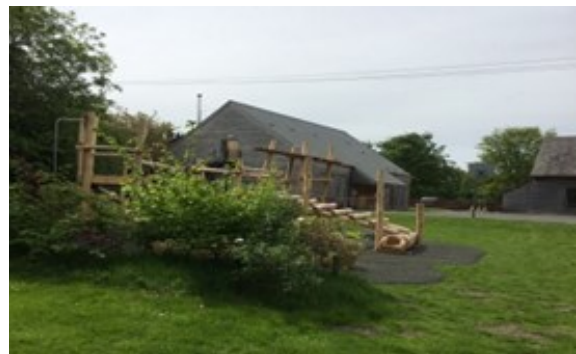
Figure 15: Village Hall and Outdoor Activity Centre

The new village hall, built on the site of the former 19th century school, is constructed of timber with a stone plinth and has settled well into the streetscape of the village. Adjacent to this the Cheviot Outdoor Activity Centre which has also followed the same style of architecture and uses the same palette of materials as the village hall.

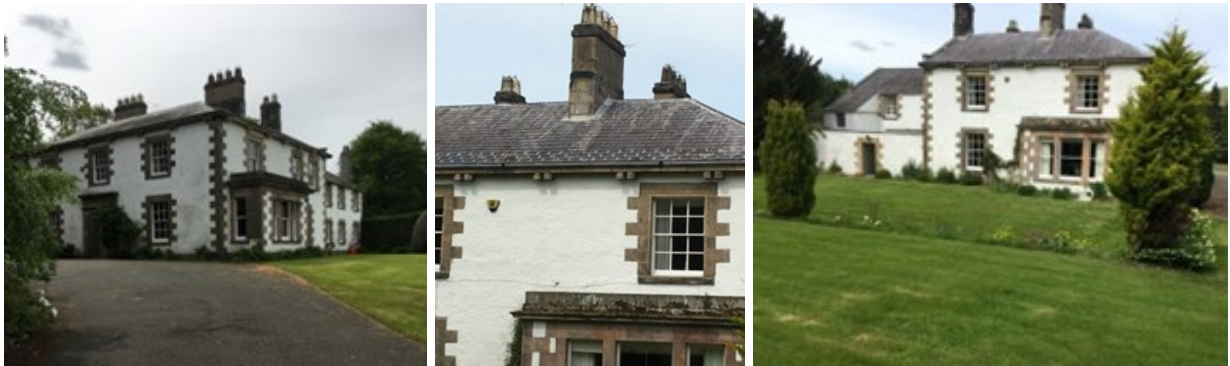
Figure 16: Kirknewton House

Kirknewton House and The Old Vicarage are two large houses which, although physically separated, are united in character type, in being large 19th century houses set within their own grounds. The dominant white render of Kirknewton House can be glimpsed through the entrance pillars from the road through the village and is prominent in the long views into the village from St Gregory's Hill. The house and gardens are obscured by mature vegetation which surrounds the plot. The house and gardens appear to have remained largely unchanged since the first edition OS map of 1860. It is more difficult to see very much of the Old Vicarage building from any public vantage point within the village. Glimpse views of the roofline, dormer windows and rear of the building can be seen from the road within the village and from the long views into the village from the hillsides. Much of the main elevation is obscured from general view by the farm buildings of West Kirknewton Farm and mature vegetation. The boundaries to the Old Vicarage appear to have remained largely intact since the 1860 First Edition OS Map. Both these buildings have a noticeable presence within the village and as such form a significant element of its character.

Building textures are a contrast of rough and smooth, as coarse walling stones contrast with dressed stone window and door surrounds and quoins. The white render of Kirknewton House is a prominent feature in the long views into the village. This contrast continues in a colour range of building materials. Mortar joints and general pointing tend to be patched up and repaired, reflecting the random nature of the material. The vivid red/orange of the pantile roofs contrast with the blues, purples and greys of the slate roofs within the village. In walling materials the blacks and greys of igneous stones are frequently set against the pink and buff sandstones. Framing the buildings are the greys of the whinstone chipping road surface dressing.

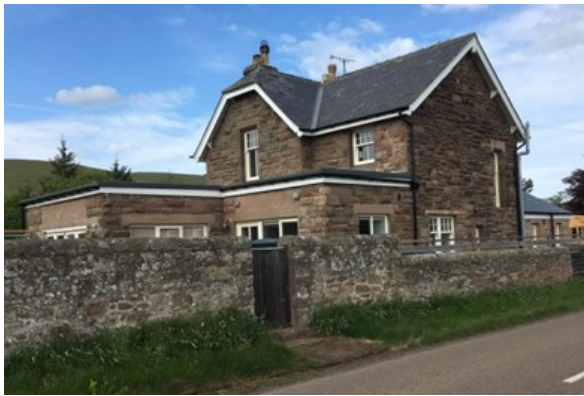
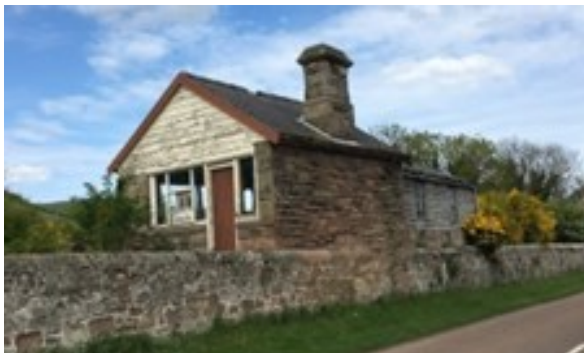
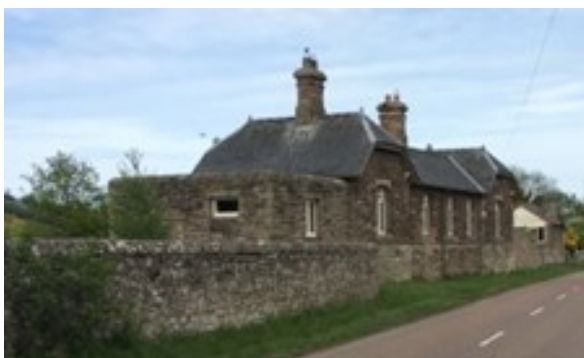
Figure 18: Station buildings

building of the Alnwick to Cornhill Railway in 1887. Railway development naturally takes a linear form which tends to be imposed upon the existing settlement pattern. In Kirknewton, the railway was built towards the floodplain away from the village, with associated development creating clear character areas away from the central core of the village. The railway associated buildings of the Station Master's House, the Station building and associated signal housing and the railway workers' cottages, which are set away from the station along Post Office Lane, are all of a distinct railway architectural style. The Station building has been sensitively converted to residential

and although the track and ballast have been removed, the buildings and earthworks retain a clear association with their former use. This set of buildings, although physically separate make an important statement about a key development in the historic of the village and as such make an important contribution to the character of the Conservation Area.

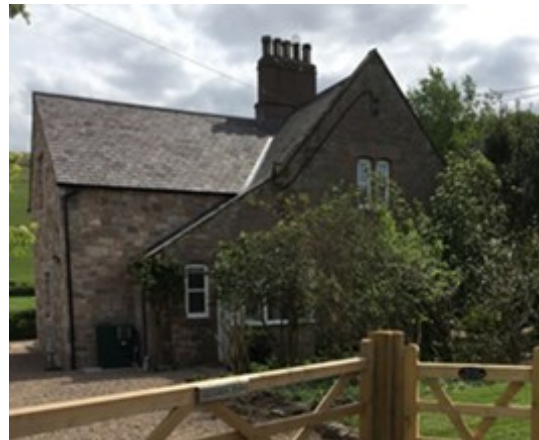
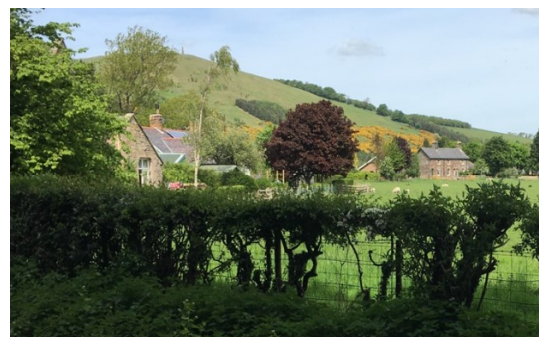
Figure 19: Station cottages and Old School House

The School House, located at the junction of Post Office Lane and the B6351, dates from the mid-19th century and is a significant departure from the vernacular character of the old village buildings and reflects a national copybook style. Gone are the igneous walling materials and plain detailing, to be replaced by coursed dressed stone and finely detailed dormers and window surrounds.

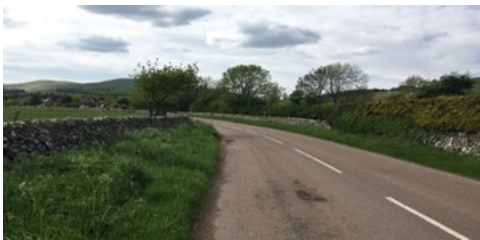
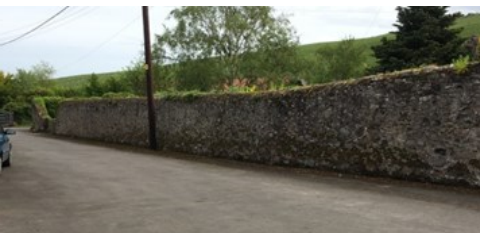
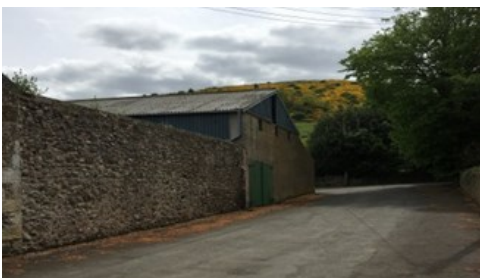
Figure 20: Stone walls

Many spaces within the Conservation Area are defined and enclosed by attractive stone walls which act as a network, connecting buildings together, as well as mature hedges. The western edge of the settlement is defined by Coronation Wood and the B6351 on the east side. The village is bounded by St Gregory's and West Hill to the south, while the northern boundary is effectively created by the line of the dismantled railway.

- ensure that all future highway work, including maintenance works, will preserve and enhance the character of the area,
- encourage the repair and maintenance of dry stone walls throughout the village, including those along the B6351,
- encourage the undergrounding of overhead cables,
- encourage through the planning process the reinstatement of missing architectural features and the replacement of unsuitable materials and details, with historically appropriate alternatives; these include

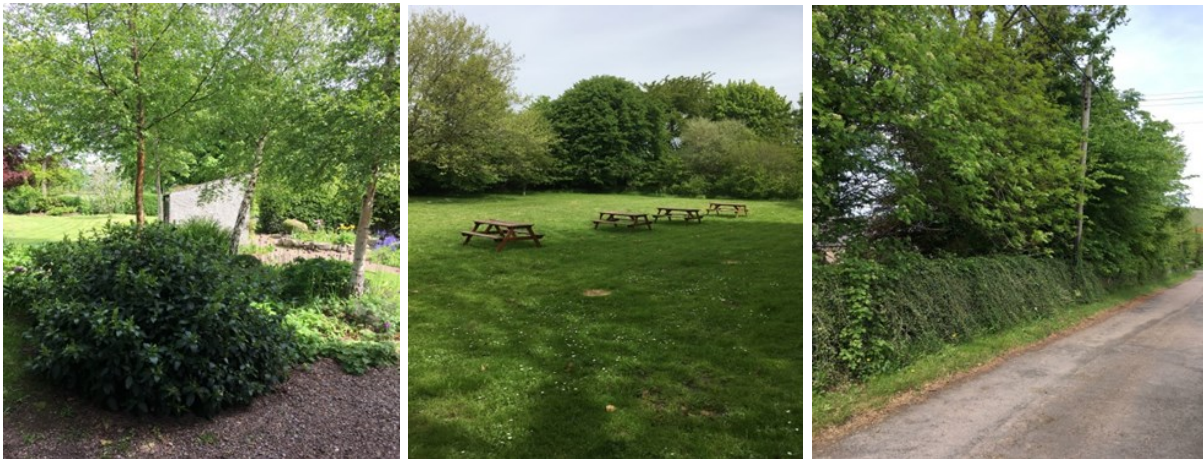
Figure 28: Trees and hedges

Well established hedges bordering the B6351 and the lane leading to the railway cottages are an important landscape feature defining the boundary between public and private space.

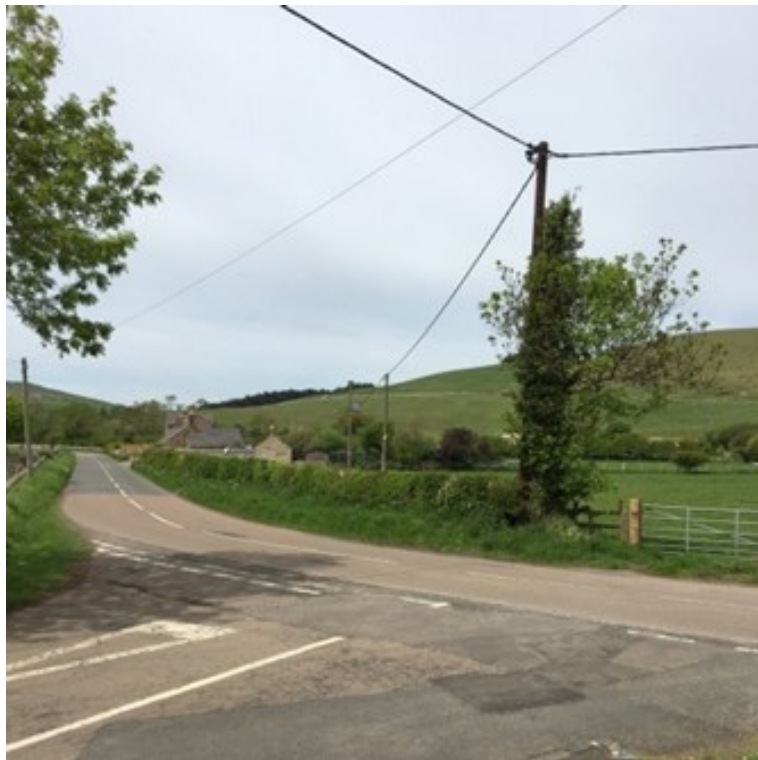
Figure 29: Overhead cables

Overhead cables detract from the rural nature of the village and the undergrounding of these could be included within management proposals for the future improvement of the character and appearance of the Conservation Area. Minor alterations to buildings can have a significant impact on their appearance such as unsuitable window and door alterations and inappropriate use of materials, including the use of cement mortar for pointing repairs rather than the use of lime mortar, which is not only more appropriate from an aesthetic point of view but also helps to preserve the stonework. Overall the buildings within the village are well maintained and cared for and help contribute to maintaining the attractive character of the Conservation Area.

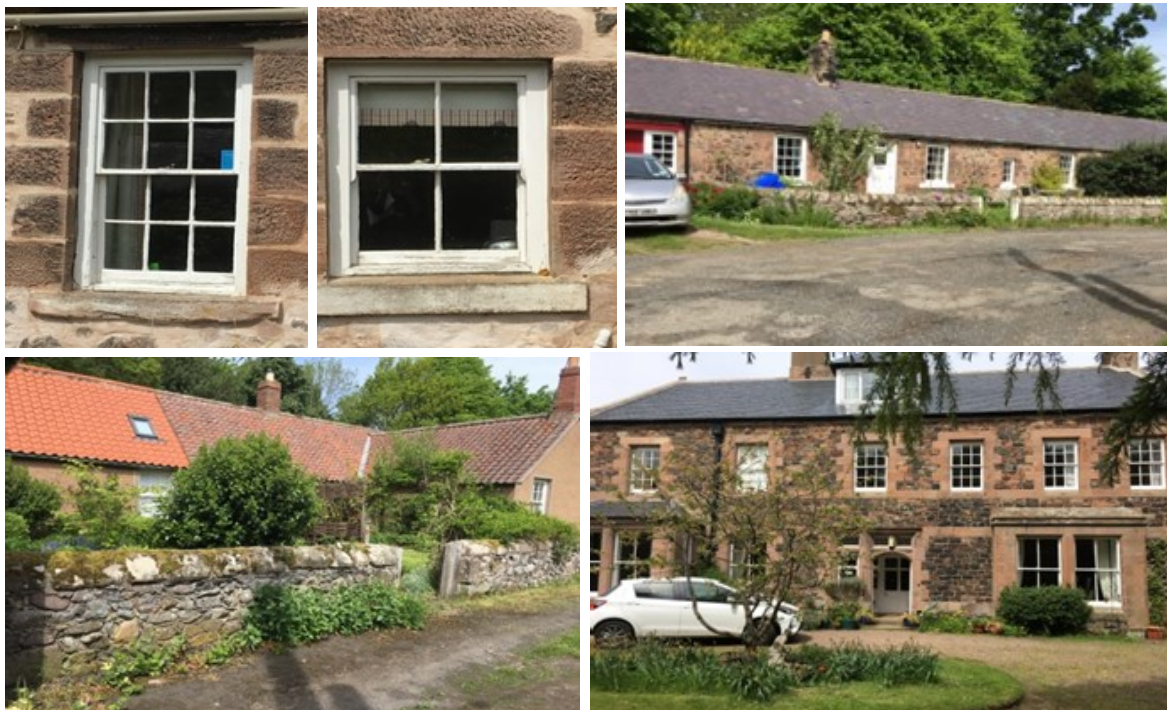
Figure 30: Architectural details – windows, chimneys, roofs, and red sandstone dressings

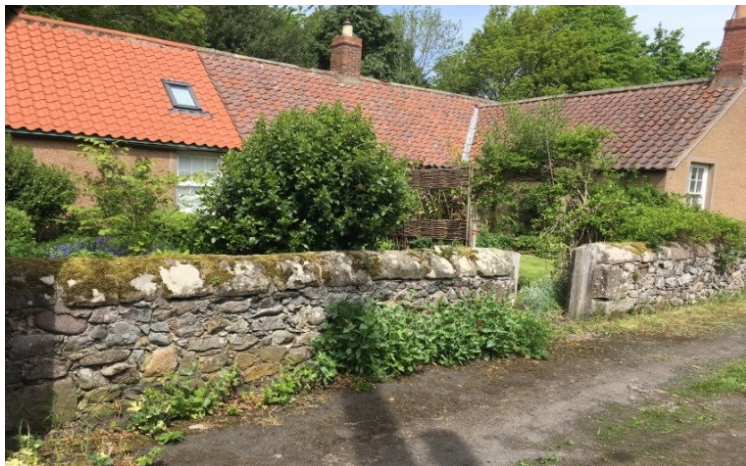
Figure 31: Pantile roofs

Walling materials are typically a mix of random igneous rubble, such as andesites, porphyritic rhyolites, granites and whin from the nearby Cheviot Massif. Being very hard and difficult to dress they were not suitable for window and door surrounds or quoins, which tend to be dressed pink sandstone. After the mid-19th century little use was made of the igneous stone with coursed dressed sandstone becoming the norm. Boundary walls contain a mixture of sandstone and igneous stones in random form. There are limited instances of stone walled buildings being covered in roughcast, a mix of small pebbles in a lime or cement mix, possibly as a response to penetrating damp. Brick is not at all dominant, although it is evident in small patches when used as a material to repair buildings, mostly farm outbuildings. Later construction materials of the 20th and 21st century include vertical boarded timber, as used in the new Village Hall.

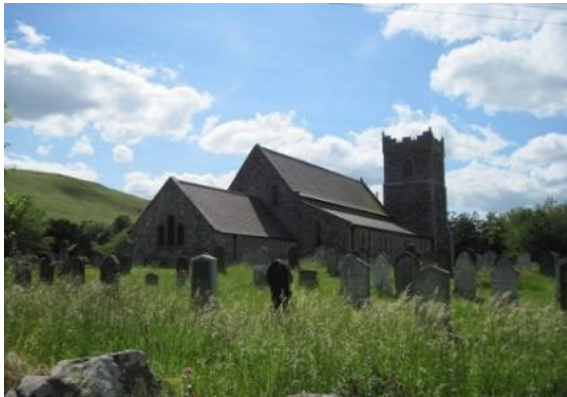
The Church of St Gregory is externally a 19th century building with a nave of 1860 by the Newcastle architect John Dobson and a later 19th century tower. Closer examination reveals the chancel to be of older masonry. The priest's door and small square window probably date from the 16th century. Internally the transept and chancel contain primitive pointed tunnel vaults rising from just above ground level. While their form would suggest a 13th century date this does not correspond with the date ascribed to the exterior. The design suggests that at the time of the border conflicts the building needed to incorporate defensible qualities.

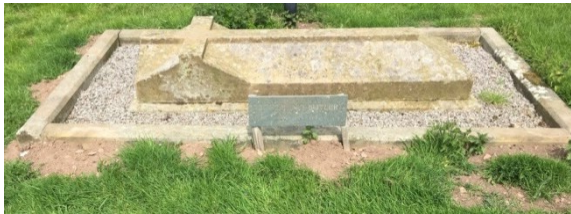
4. Davison Chest Tomb: Grade II

The Davison Chest Tomb is roughly 7 yards south of the church, dated 1738 and ashlar with angle pilasters on the sides of the chest, with worn decorative panels. The top has a rounded edge and a broad chamfer and flat top. The chamfered west end of the chest has a coat of arms with the date in high relief letters, and worn inscriptions around the edge, one stating the death of James Davison of Lanton who departed this life March ye 27th 1767 aged 101 years.

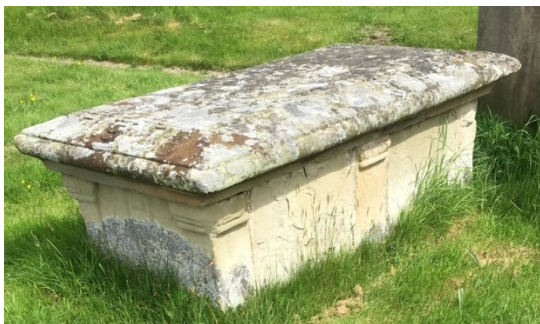
5. The Davison Table Tomb: Grade II

This tomb is about 9 yards south of the church with various dates from 1774 to 1806 dedicated to the Davison family, made in the ashlar style it is supported at the corners by urn balusters on the side with relief carvings of lily leaves with the top having a moulded edge.

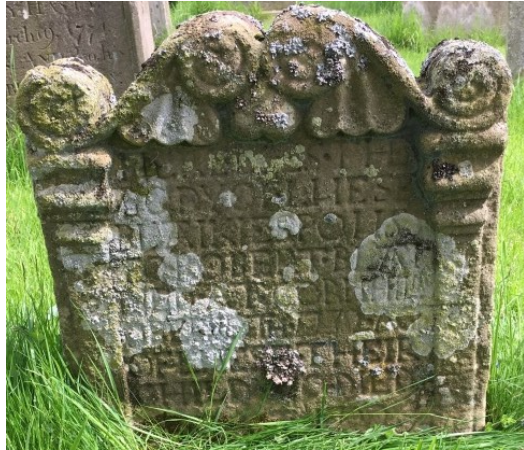
9. Small gravestone 35 yards south of the Church of St Gregory: Grade II

The date and inscription of this small gravestone is indecipherable but probably 18th century. It is approximately 2ft high with pedimented top with two panels beneath, one with carved cherub and the other with a skull and cross bones.

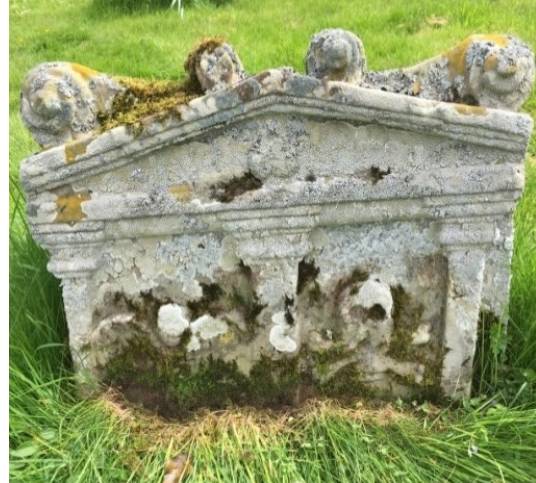
8. William Gravestone: Grade II

This is 18 yards south-south-east of the church dated 1736 made from sandstone. It is a 2 foot high tablet with fluted pilasters and semi-circular pedimented top with a moulded edge. It is illustrated with cherub heads in the pediment and a skull and crossbones with the words 'memento mori' below and a worn inscription to rear.

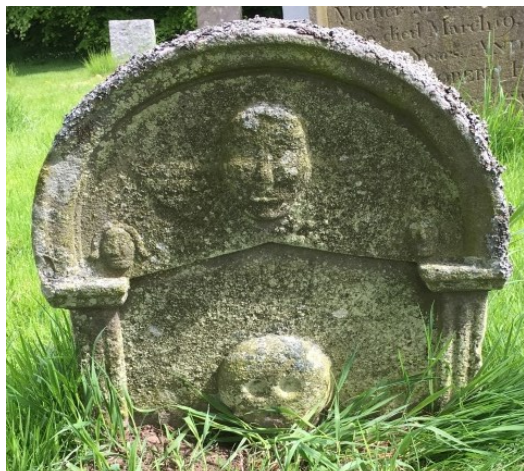
10. Gravestone approximately 30 yards south east of the Church of St Gregory: Grade II

This gravestone is a small tablet of approximately 18 inches high. A cherub's head and wings are carved into the pediment with a sand timer below and a skull framed by a banner with a worn inscription.

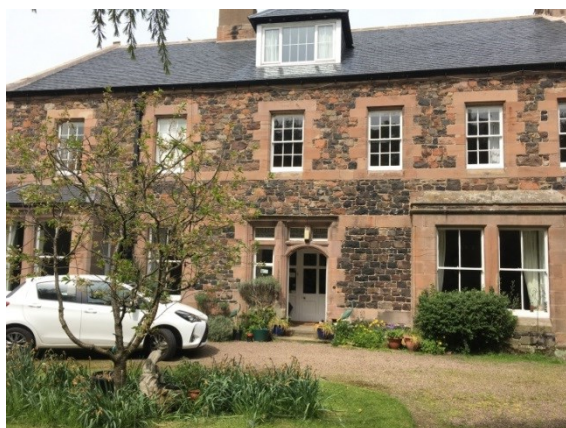
The Old Vicarage is now a private house and the older parts date from the late 18th/early 19th Centuries and has extensive additions from the 19th century. It is a two storey 'L' shaped construction and made from random rubble with ashlar dressings and Welsh slate gabled roof and large hipped dormer, flat coping and end stacks. The entrance is a Victorian door with segmental head, mullioned overlight and multi-moulded surround. There is similar detail to side light on left of door and they both have a floating cornice above. To right of the door there is a shallow single-storey two-light bay window with a stone pent roof and the deeper square bay window to left of door has slate pent roof. The windows are all sashes with a four-pane chamfered surround on the ground floor, while the first floor has six-pane sashes in chamfered surrounds.

The older wing of the vicarage on the right return has one twelve-pane sash window on ground floor and three windows on the first floor, one a sixteen-pane sash window with the others having the intermediate glazing bars removed.

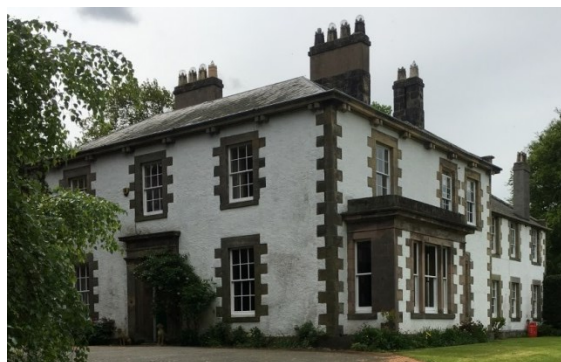
Kirknewton House is a square two storey building of 1852, constructed of random rubble masonry covered in painted roughcast. It has ashlar quoins, plinth and dressings. It is a two-storey construction with bays and a lower service wing to the rear. The entrance front is of three bays with a Tuscan door case and a four-panelled door. The ground floor has two-pane sashes and 12-pane sashes on the first floor, all with alternating block surrounds. Kirknewton House also has projecting eaves with paired stone brackets and the roof is 'U' shaped in plan with four ridge stacks. The returns have ground floor square bay windows with tripartite sashes and moulded cornices, with the remaining windows having 12-pane sashes. The interior of the house has stick baluster staircase with turned newels and weathered handrail.

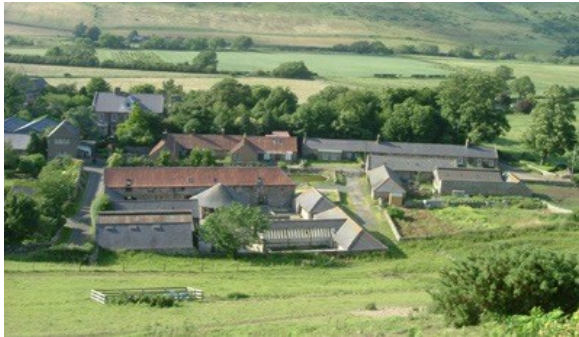
drive a threshing machine, is a round building with a conical Welsh slate roof and dates from the 18th century. It has boarded doors and a half shuttered blacksmith type window. Attached to the gin gang is a two storey threshing barn and granary. On its south side on the ground floor are three elliptical arches of the Hemel storage area, above which are four 'hit and miss' slatted ventilation openings to the granary. Projecting from either end of this building are single storey shelter sheds. This is an important group of farm building which has altered little since its construction and has recently been converted to residential use.

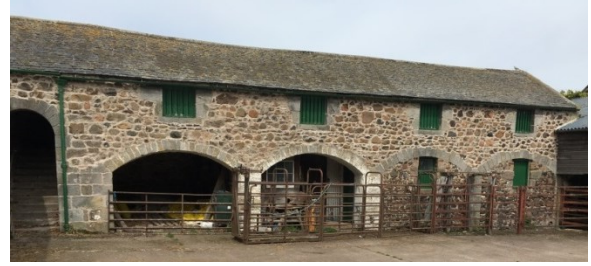
14. West Kirknewton Farm: Grade II

West Kirknewton Farm has a late 18th Century granary. The Shelter Sheds and Granary at interest. The buildings are of two storeys with nine bays with an interesting central round arched entrance to the granary stairs. In common with most of the village's farm buildings it was contrasted using random igneous rubble with dressed sandstone quoins and surrounds. The roof is Scottish slate.

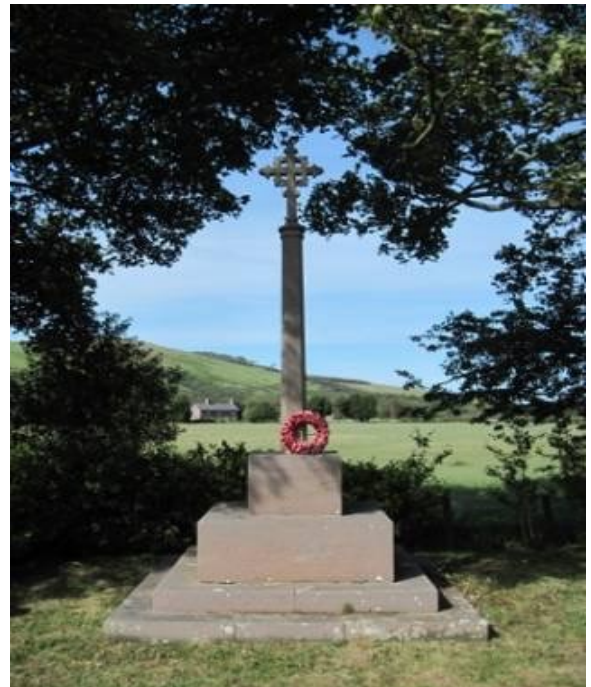
15. War Memorial: Grade II

The War Memorial is located at the east end of the village and was probably erected in 1919. It consists of a slender tapering shaft with broach stopped chamfered edges, a moulded top and foliated cross on a base of two square steps and two larger inscribed blocks. On the second step the inscribed passage reads; God asked Britain's homes a costly sacrifice and these ungrudging paid the price.

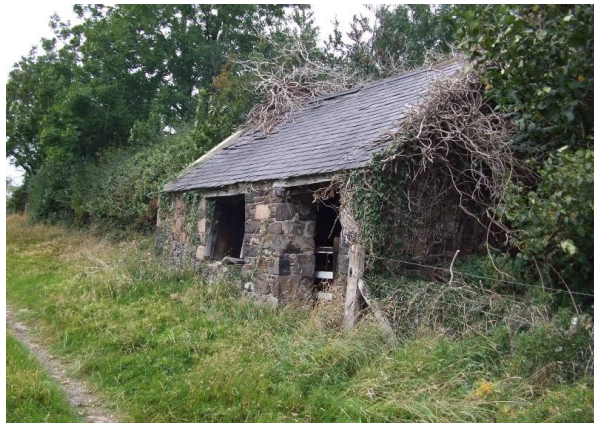
An early 19th century Blacksmith's Forge lies 250 yards south-west of Kirknewton House. It is disused but substantially complete internally with the forge and bellows in situ. It is a small, single storey building with a boarded door and one shuttered window.

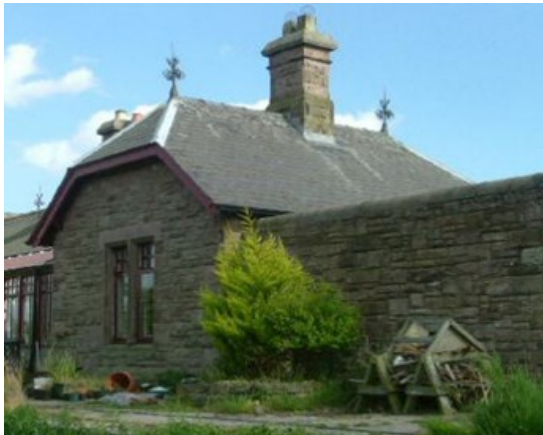
6. Old Station House

The former Stationmaster's house has been sensitively restored and retains its original form although a large extension has been added. The same can be said of the three Railway Cottages, also of c.1887. Elements of the former railway track bed and embankment remain and correspond with the northern boundary of the settlement.
