# Northumberland County Council

## Route Road Safety Study

### B6318 Heddon-on-the-Wall to A68 Errington Arms Roundabout

DATE: February 2023

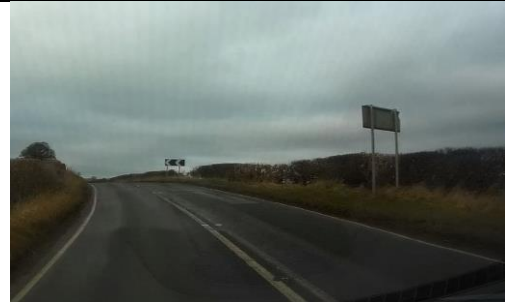
**Photo 6- Example of location where enhanced chevron signing on bend may be beneficial along with road marking/stud refreshment.**

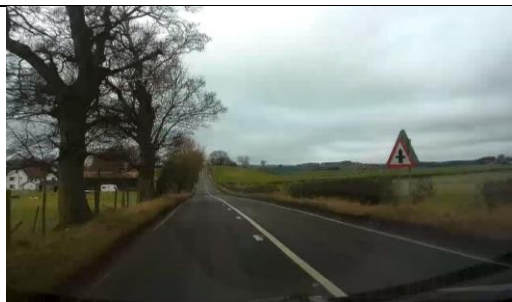
**Photo 7- Example of location where enhancement of the warning sign, with a supplementary distance plate may be beneficial.**

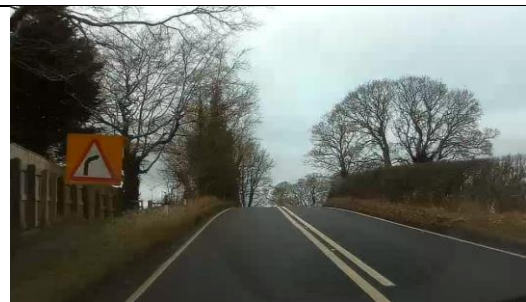
**Photo 8 - Example of bend warning sign which could benefit from an appropriate reduced speed supplementary plate**

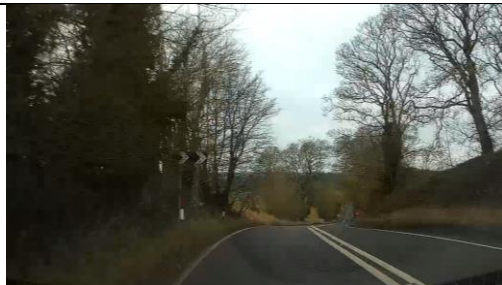
**Photo 9 – Chevron sign is hidden within vegetation – suitable clearance required and sign enhanced on yellow backing board.**

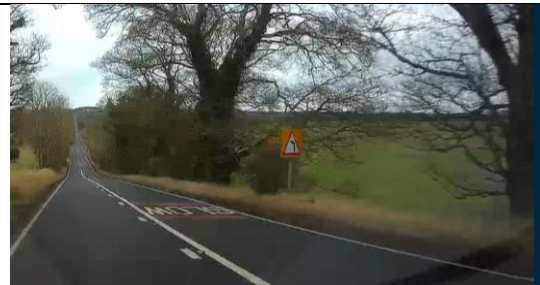
**Photo 10 – Warning sign twisted to face in wrong direction and sign may benefit from an appropriate reduced speed supplementary plate**

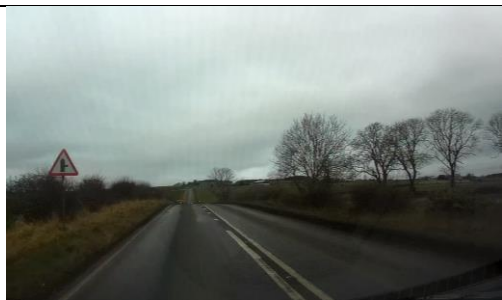
**Photo 11 – Ensure termination of double white line system is located correctly, opportunity to enhance junction warning sign and provide SLOW roadmarkings and red surface strips.**

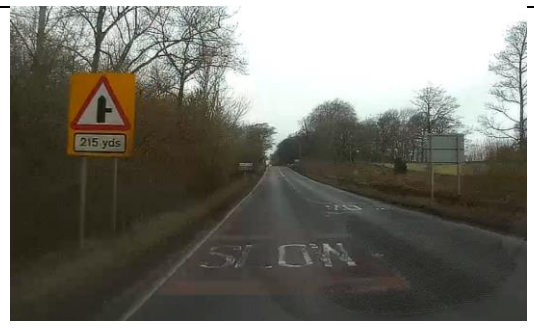
**Photo 18 – Example of use of yellow backed junction warning sign with supplementary distance plate.**

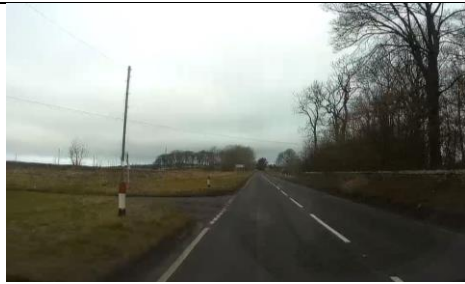
**Photo 21 - Example of use of marker posts to highlight presence of minor side road junction.**

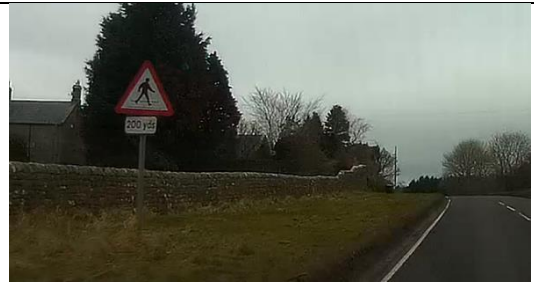
**Photo 22 – Incorrect signage in place for a location where pedestrians cross.**

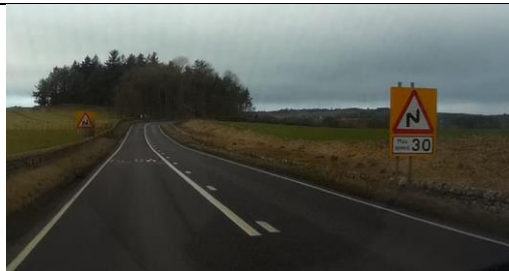
**Photo 23 - Example of use of double banked double bend warning signs with advisory speed limit supplementary plate.**

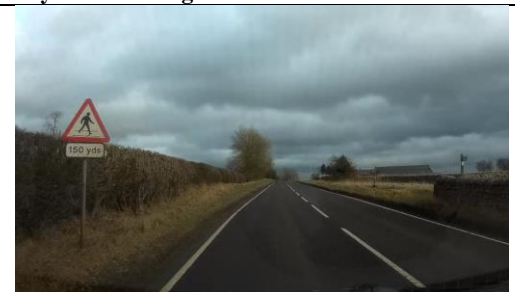
**Photo 28 – Incorrect signage in place for a location where pedestrians cross.**

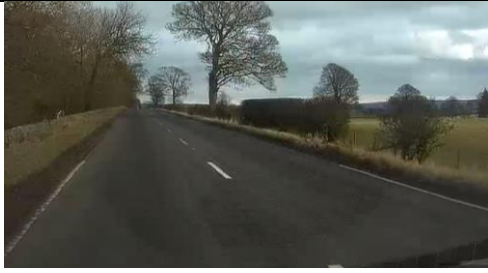
**Photo 29 - Example of indistinct road markings beyond another section of road markings which have been refreshed more recently.**

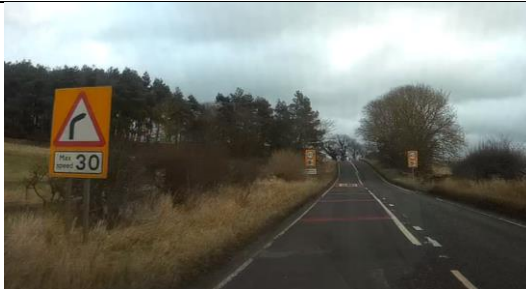
**Photo 33 - Example of use of yellow backed warning sign with advisory speed limit. Note however that the advisory speed limit conflicts with the 40mph speed limit terminal signs a short distance ahead.**

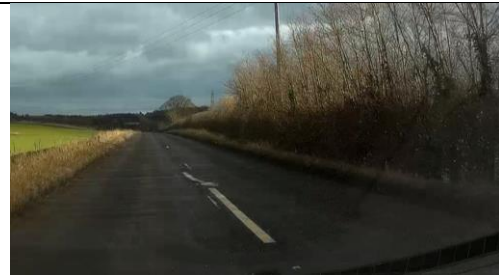
**Photo 38 - Example of indistinct road markings beyond another section of road markings which have been refreshed more recently.**

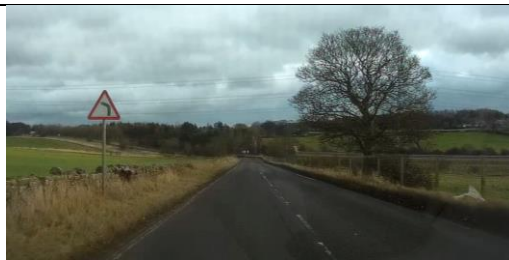
**Photo 39 - Example of warning sign and chevron sign in advance of and at bend which could be enhanced and provided with SLOW road markings and red strips and refreshed markings and studs.**

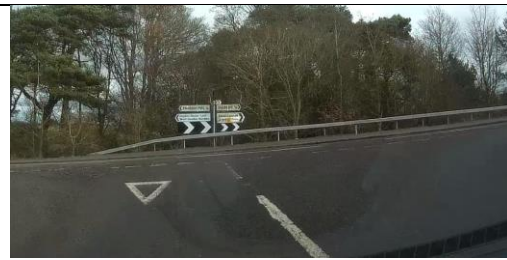
**Photo 40 – Chevron “target” signs installed incorrectly. Left chevron should face left or location may appear to be a right bend from a distance.**
