Appendix 1B

Survey of Reinforced Concrete Details and Lintels at the
Maisonette Blocks in Blyth

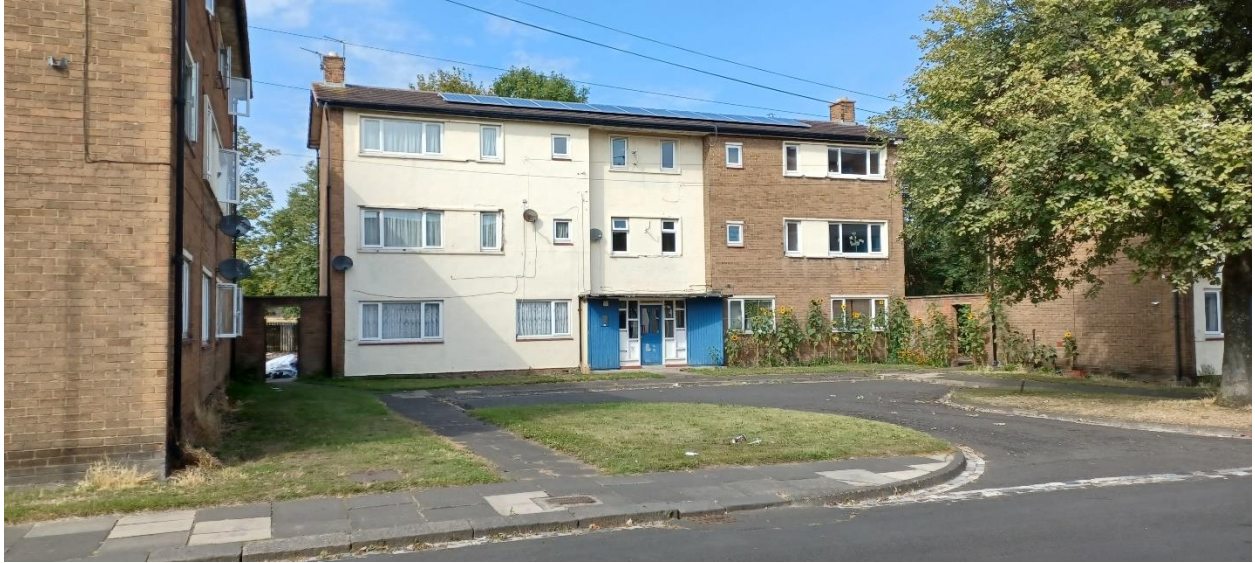
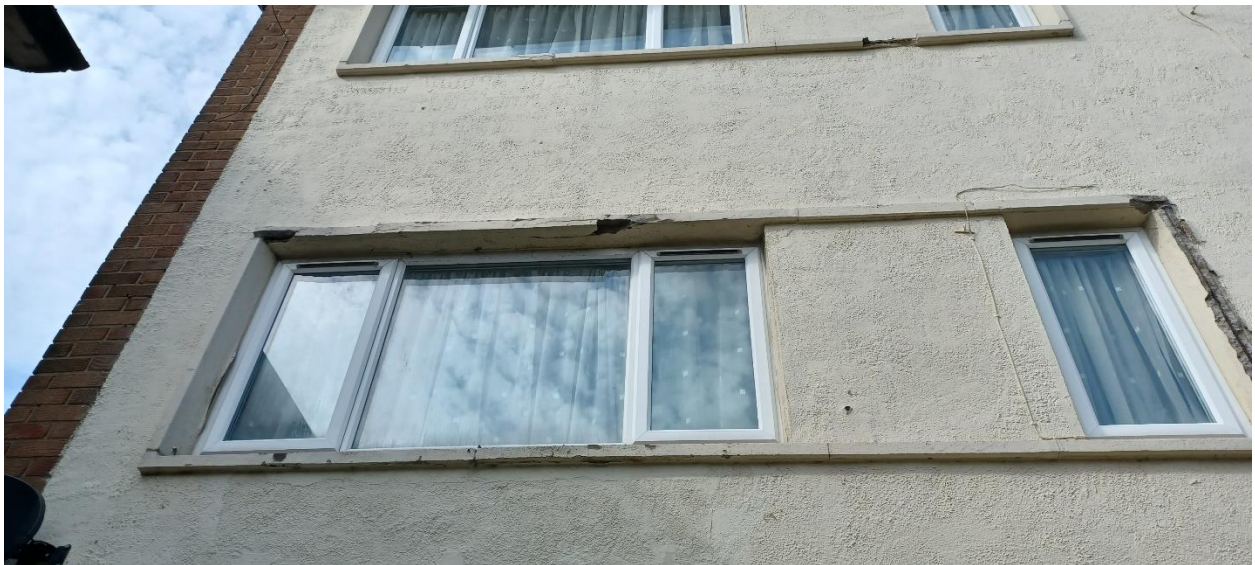
Projecting boot lintels and projecting concrete surround detailing - The condition of the exposed reinforced edges of all projecting boot lintels and concrete surround details vary in severity but they generally show signs of the same defects. The steel reinforcement in the concrete has corroded causing the steel to expand which has cracked the concrete. *The cause of the defect is due to carbonation* and the projection on the concrete detail has allowed the concrete to become saturated and retain moisture longer than if it was flush with the brickwork.

The photo below taken on the front elevation shows missing concrete on the projecting concrete cills and cracks on the boot lintels and side details.

A permanent solution will involve erecting scaffolding, removing loose concrete, descaling and cleaning the steel reinforcement to a shiny surface finish, applying anti-corrosion paint to the steel to protect it from water and chemicals, installing stainless steel fixings, adding temporary shuttering to the areas and applying a specialist repair mortar. All the existing concrete details will then need the surfaces cleaned of all existing paint and an anti-carbonation coating applied to reduce and slow down the carbonation process in the areas both repaired and not repaired. The paint will also be needed for aesthetic reasons if the building is not rendered on completion of the works.

The cheapest solution is a temporary measure which will involve hiring a Cherry Picker to remove the loose concrete to prevent it from falling off. The steel reinforcement could be painted with a specialist paint to reduce further corrosion and minor mortar repairs done to shed the rainwater whilst a permanent solution is agreed upon.
